National Park Service Jefferson National Expansion Memorial Gateway Arch

St. Louis, Missouri

Historic Structure Report – Volume 1

June 2010

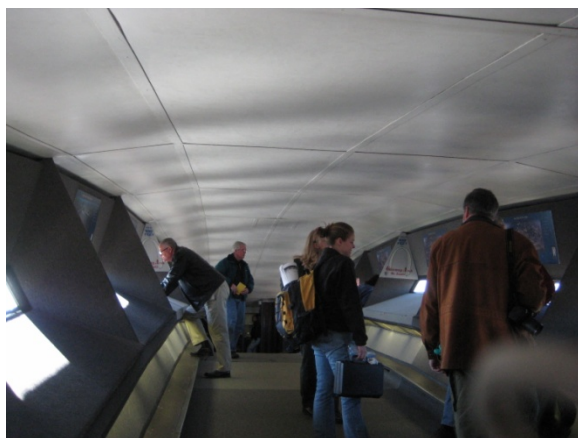
The ceiling of the observation deck consists of white painted steel plates and steel ribs (Figure B-1). Samples 2, 3, and 4 represent the ceiling and likely contain complete stratigraphies. The ceiling was originally primed with a red primer and a gray green intermediate coat. The original exposed finish of the ceiling is gray in color, closely matching Munsell colors 10PB 7/1 and 10PB 6/1 (Figure B-2). The original color remains exposed in the ceiling of the closet at the observation deck (Figure B-3). The color of the closet walls at the observation deck at the north was measured using a spectrophotometer. The average color of the closet at the observation deck at the north was $L^*=51.92$, $a^*=-0.36$, $b^*=4.66$. The color of the closet at the observation deck at the south was measured using a spectrophotometer. The average color of the closet at the observation deck at the south was $L^*=63.99$, $a^*=-0.50$, $b^*=7.11$. The ceiling subsequently has been painted a series of grays and off-whites. The walls to the observation deck are currently carpeted. The current carpet was reportedly installed in approximately 2002.

Figure B-1, left. Overall view of ceiling at observation deck. Source: WJE, 2008. Figure B-2, right. Photomicrograph of Sample 2, removed from the ceiling of the observation deck. Red layer indicates primer coat. Source: WJE, 2009.

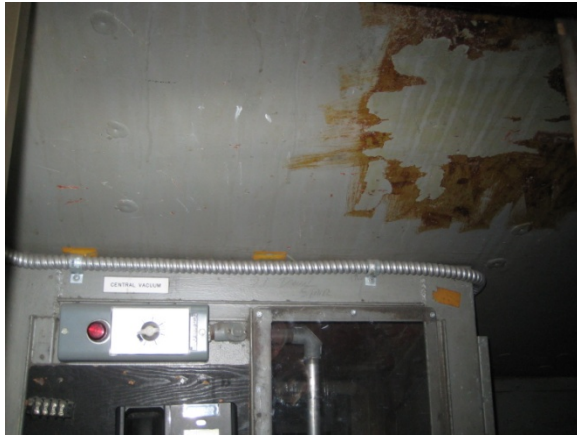
Figure B-3, left. Overall view of ceiling at observation deck closet. The gray color likely represents the original ceiling color in the observation deck. Source: WJE, 2008. Figure B-4, right. Overall view of observation deck tram loading area. Source: WJE, 2008.

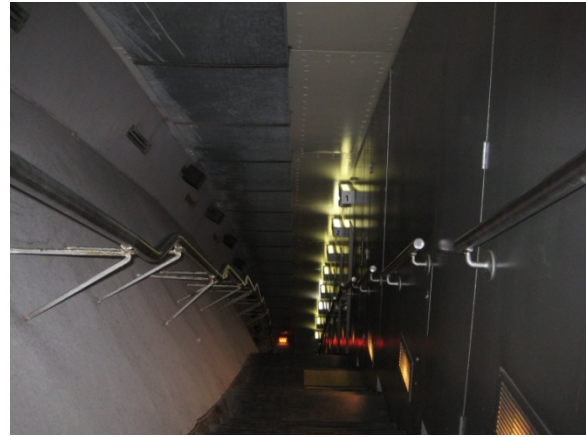
The white painted steel ceiling panels and the carpeted walls in the observation deck continue into the tram loading area (Figure B-4). The walls on the tram entrance are currently painted a metallic gray color (Sample 5). The samples likely contain the original coatings. The wall panels were originally painted a gray color closely matching Munsell N4.75 (Figure B-5). The railing supports and stair stringers were also originally painted gray, closely matching Munsell color 10PB 6/1.

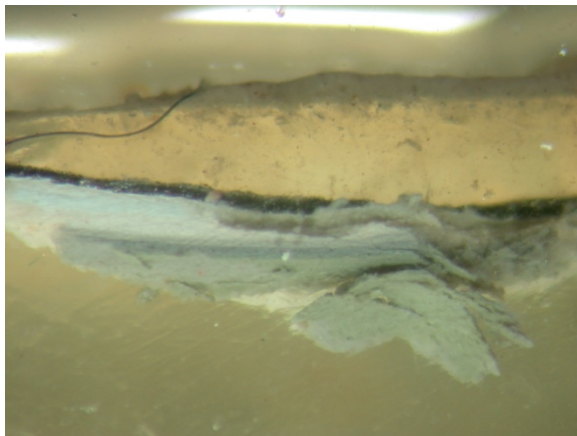
Figure B-5. Photomicrograph of coating sample removed from wall at tram entrances. Source: WJE, 2009.

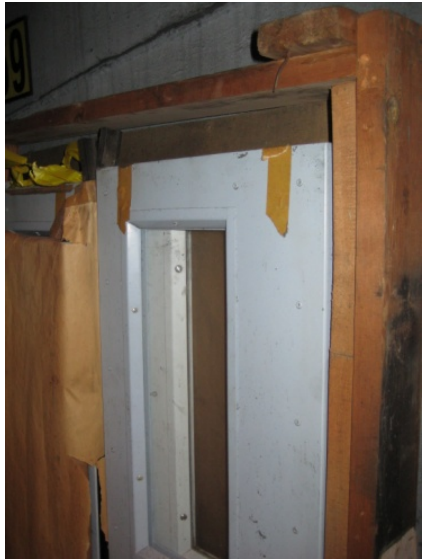
Figure B-6. Overall view of attic stock tram doors with original blue coating on the interior of trams exposed.
Source: WJE, 2008.

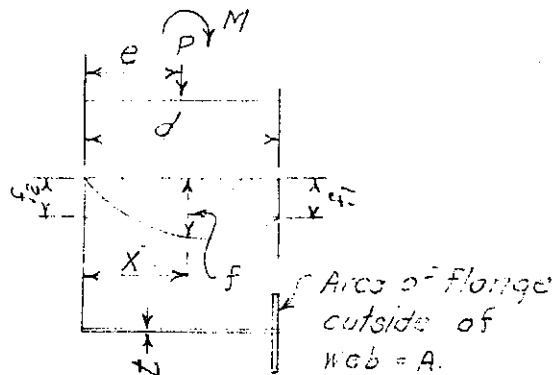
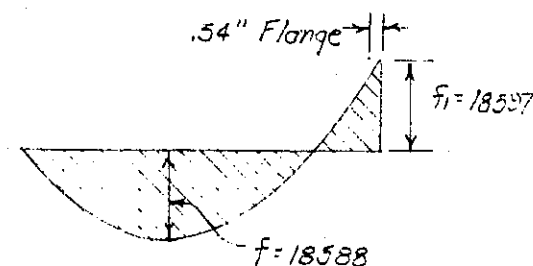
Final Stress Distribution Sec. A-A

Check Section A-A at Joint
(See Sheet 25.1 for Joint Details)

The welds on the present design are stressed to failure. These could be improved by making full penetration welds, but base metal is overstressed at several points, even to failure. Therefore no further consideration will be given to the present design.

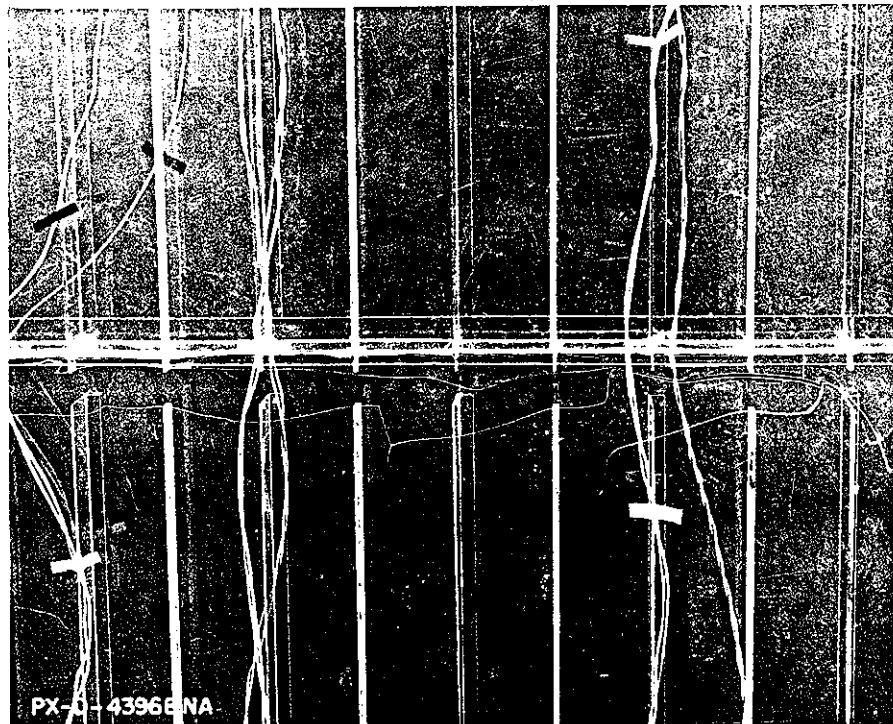
Figure Y-2

Failure of Exterior Skin Plate

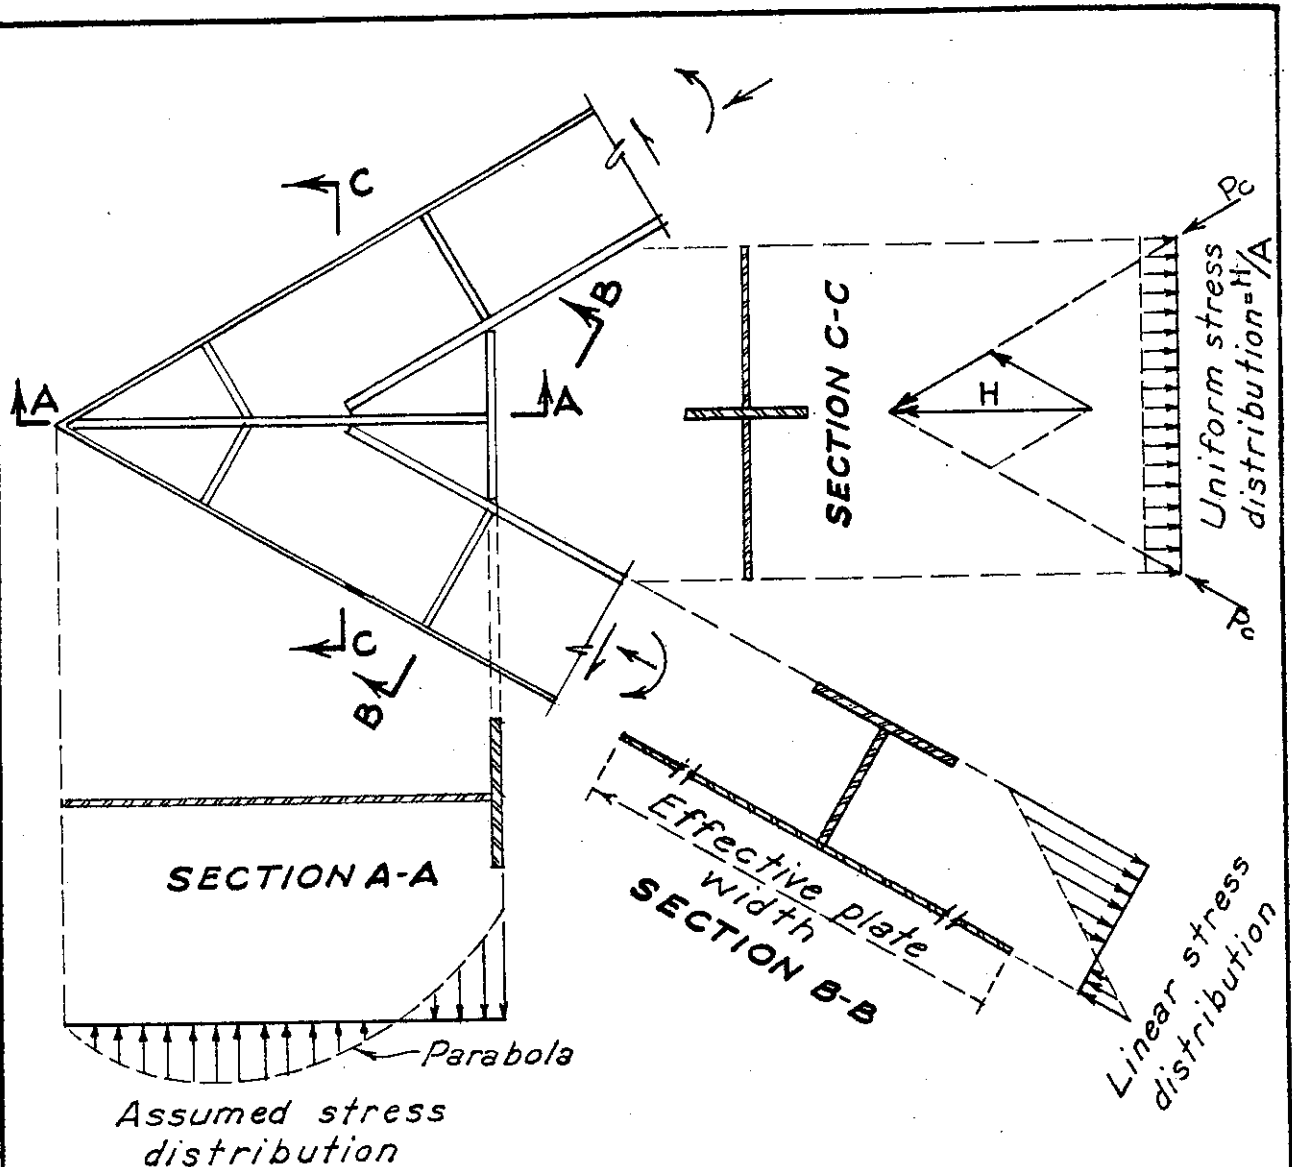
Figure V-5
RIGID CORNER
ASSUMED STRESS DISTRIBUTION

The rigid corners, as presently designed, will fail first in the 1/4-inch fillet welds along Section A-A, Figure V-5. See results pages Vf 8 and 9. These welds could be strengthened but the base metal in this area is overstressed. The principal stresses along Section A-A are of nearly equal magnitude but opposite sign which is probably the worst possible combination. The various theories of failure for ductile metals show that failure must occur in the web plate in this area. The condition created here is not one in which the stress is always of the same sign but reverses as shown for Case A1 and A2, Section A-A South, Sheet Vf 11. Reversal beyond yield point will ultimately produce cracking or total failure.

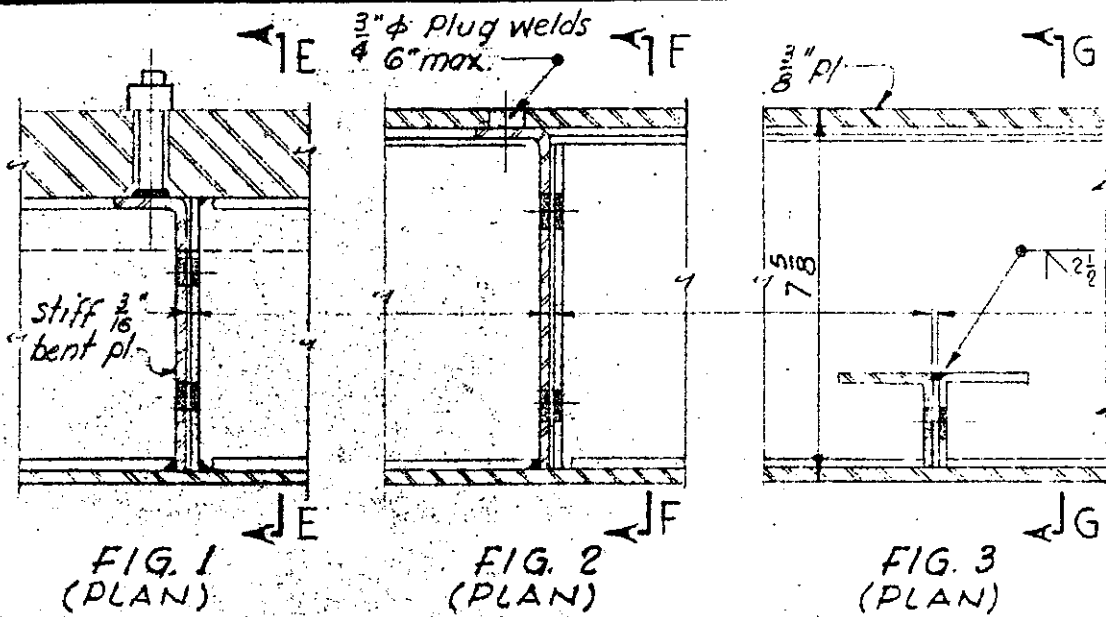
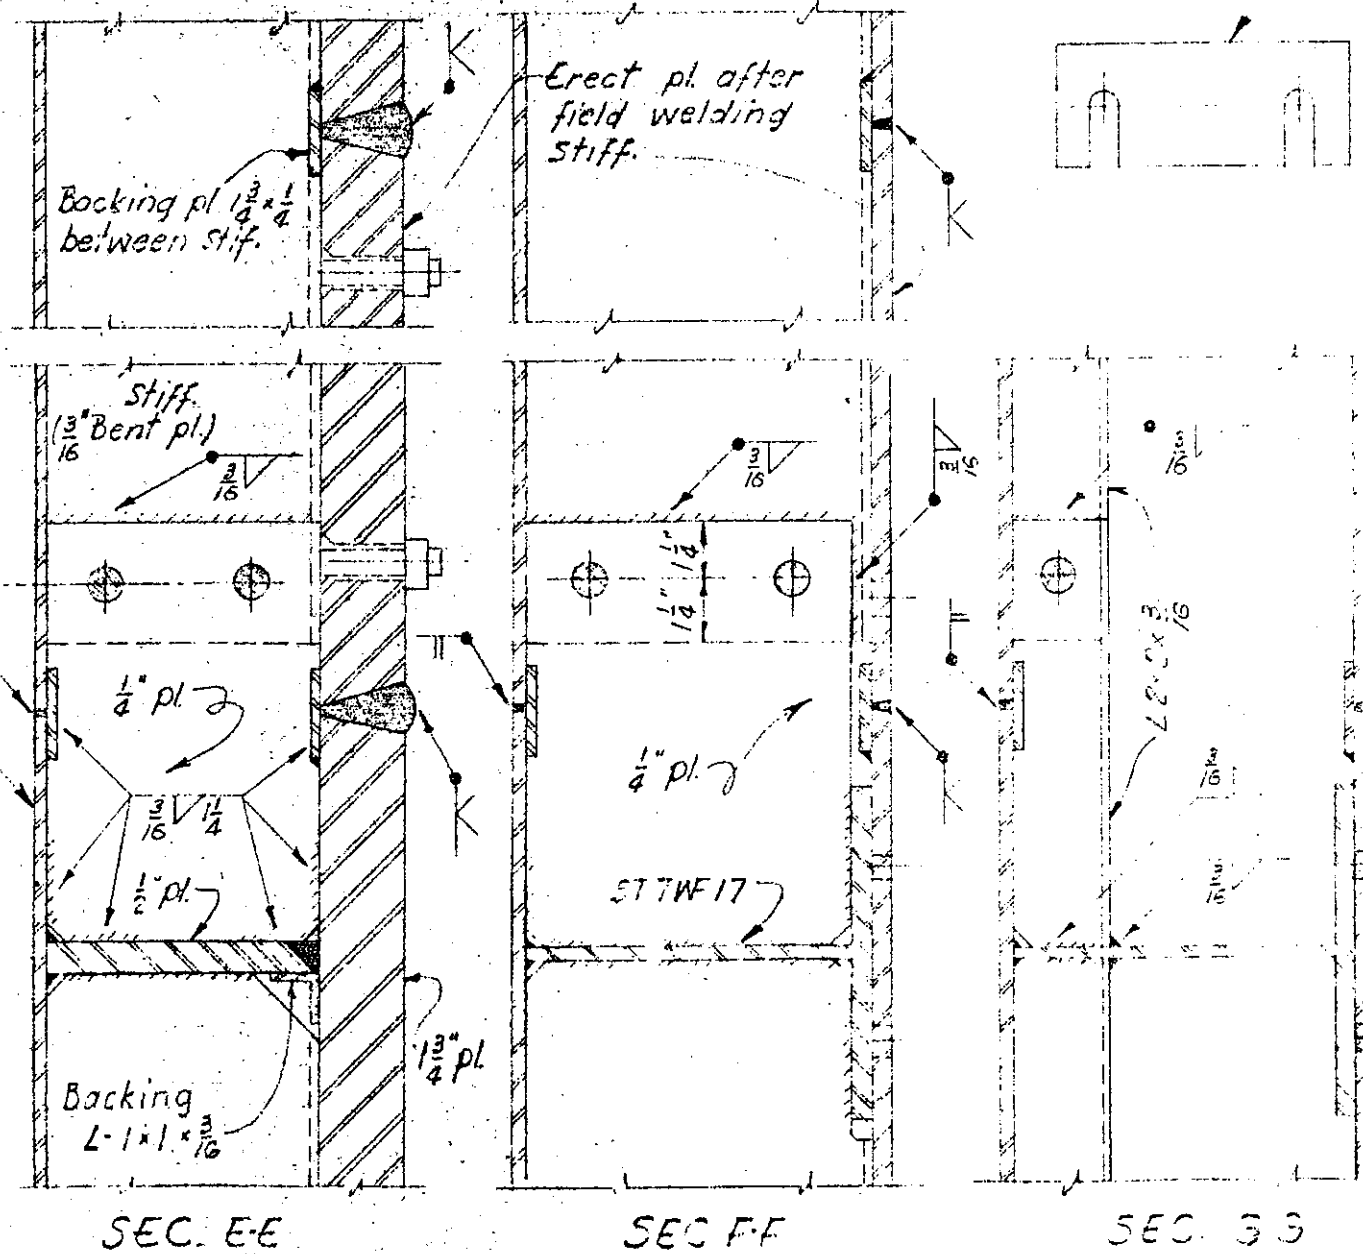
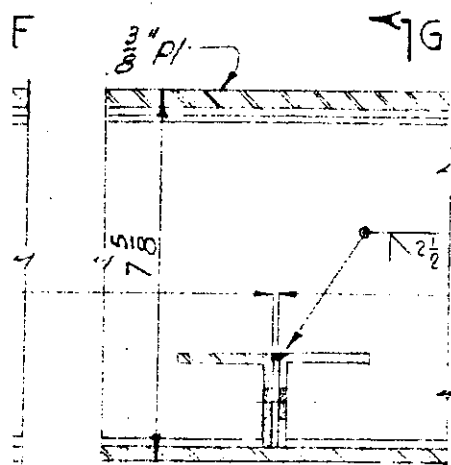
It is very clear that many advantages are derived from the hinge. The analysis is made simpler and uncertainties in assumptions are greatly reduced. Less metal will be required, difficult welding will be eliminated, and the resulting structure is permitted to "breathe" with temperature variations, thereby almost eliminating thermal stresses in the transverse direction. Buckling conditions are also greatly improved.

In computations that follow, the frames at Stations 15 and 44 are analyzed for various loading conditions, also for the frames as detailed, with modified joints and with hinged joints. Two corner modifications are considered at Station 15. Modification No. 1 was tried because it would require a minimum amount of change, but in our opinion the resulting corner is not adequate; therefore, Modification No. 2 was designed. Only one modification of the corner at Station 44 was considered in the computations which is similar to Modification No. 2 for Station 15. These computations show that it will be unsafe to use any type of rigid corner in the vicinity of Station 44. Modification No. 2 for Station 15 is detailed on Drawing No. X-OA-D-908. Hinged joints are detailed on Drawings No. X-OA-D-903 and X-OA-D-905.

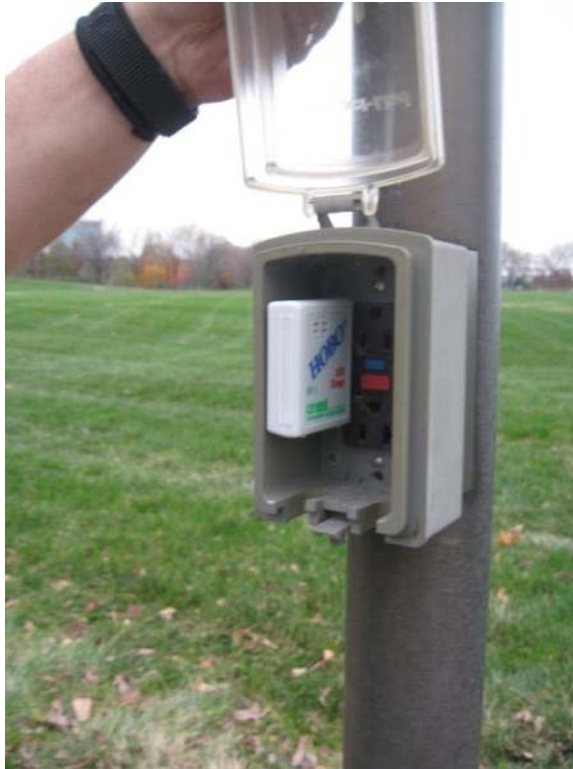
Figure 2. Monitor #1 is located in the electrical outlet box on light pole #38, located on the path leading to the south entrance.

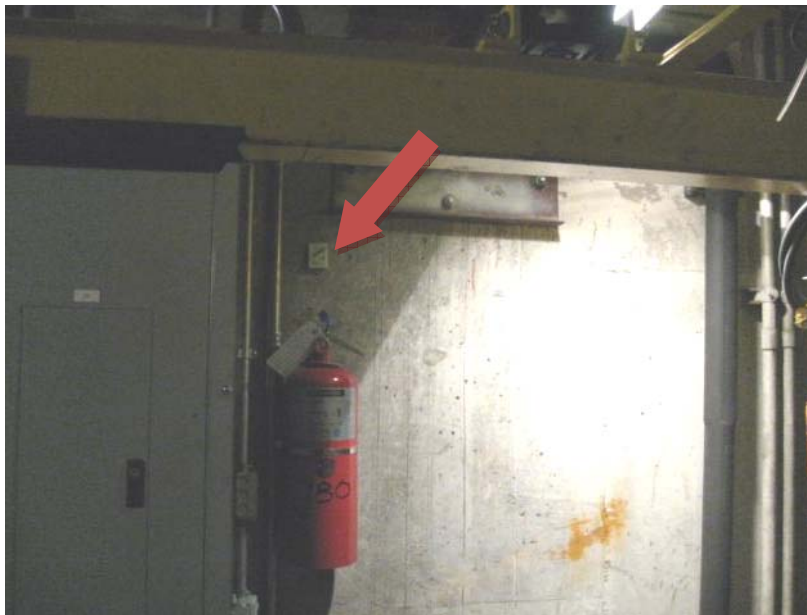
Figure 3. Monitor #, as indicated by the arrow, is located just to the north above tram loading area in the foundation of the South Leg.

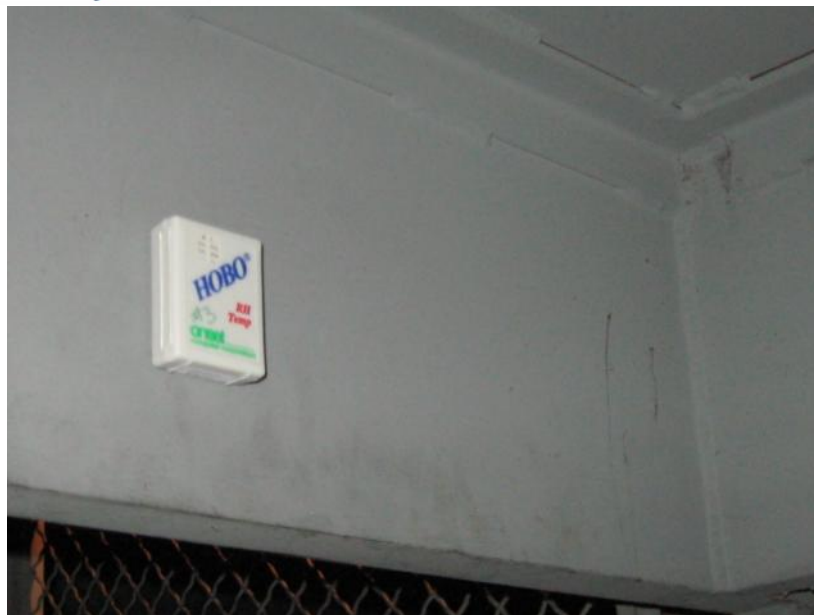
Figure 4. Monitor #3 located in the upper portion of the South leg on the backside of a beam supporting the landing of the stairs at the base of the spiral stairs. (Located around panel #14)

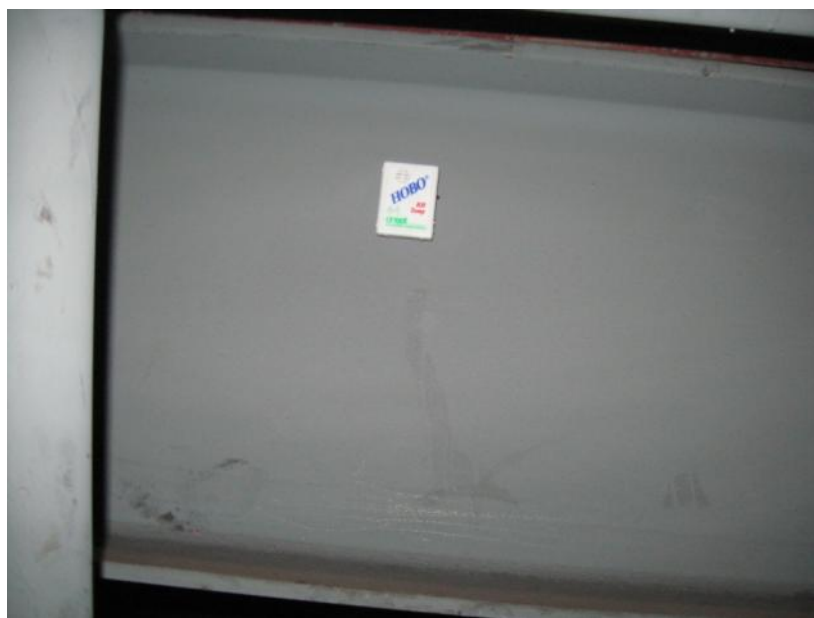
Figure 5. Monitor #4 located at the transition between steel and concrete fill of the South leg on a framing beam. (Located around panel #46)
